### Featuring Cardinal IG

### The Twenty Year Difference

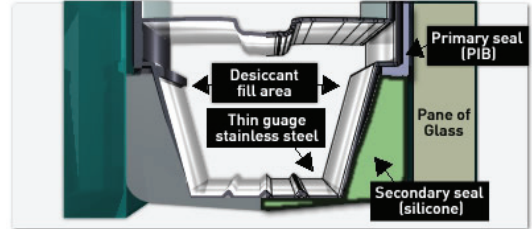
Cardinal's superior IG construction translates into a 0.2% seal failure rate over twenty years - plainly the lowest in the industry. To compare, the well-established 1976 Sealed Insulating Glass Manufacturing Association (SIGMA) study identifies average industry IG failures of over 9% in fifteen years. Modern competitive spacer systems simply cannot match the long-term durability characteristics of XL Edge IG.

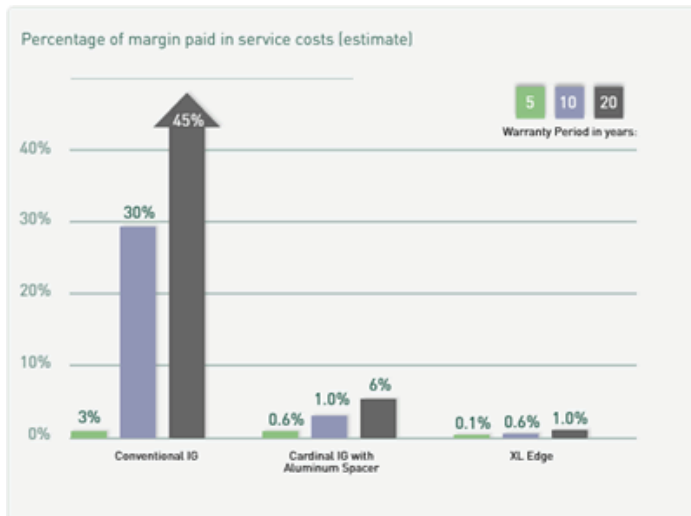
This graph estimates the cumulative percentage of your profit margin from window sales that can be lost to service costs. Over time, conventional IG units are increasingly prone to failure. The longer the warranty period, the more your profits may be eroded by service costs.

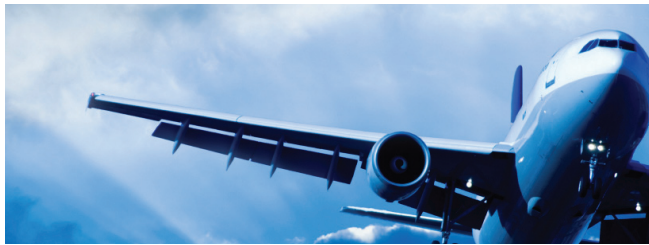
The following establishes a simplified procedure that can be followed by a building designer to make a preliminary evaluation of the minimum required glass Sound Transmission Class (STC) needed for exterior windows and/or skylights of a building subject to aircraft, highway traffic, or rail noise. These are the most commonly occurring sources of excessive exterior noise exposure.

Local building codes may regulate construction of buildings with excessive exterior noise exposure, to meet or exceed a STC rating. Unlike other fenestration value requirements, higher glass STC ratings indicated higher performing products. A STC requirement of 35 is common for construction near airports – therefore a STC rating of 35 or greater would qualify.

Theoretically, STC ratings have no upper limit in range; however, logistically there are some limitations. The entire building envelope is normally considered when addressing noise reduction. An STC of 35 would indicate a level of noise reduction such that otherwise loud noises would be reduced to a murmur. A rating of 45 begins ‘sound proofing’ where a majority of all sounds is blocked or greatly reduced. This might be a goal value of an interior wall of a home that features a high-end home theatre system in a particular room. 60 or higher provides superior ‘sound proofing,’ most sounds inaudible.
